## Structural maintenance of concrete roads: replacement of concrete slabs on the A1 West Motorway – a Case Study

## 3. Replacement of concrete slabs on the A1 west motorway in the area of the St. Georg motorway junction

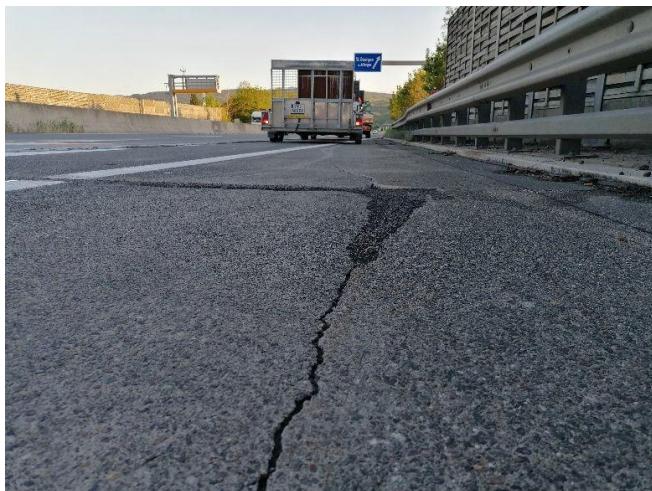
**Figure 8.** Cracks and damaged surface filled with cold asphalt  
*Source: Author 2021*
